Home Inspection Report

Street Address, City, MN 56329

Report Number:

20180729-01

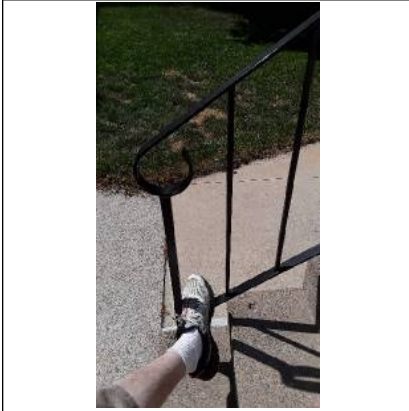
For enhanced safety recommend 4" max spacing between balusters.

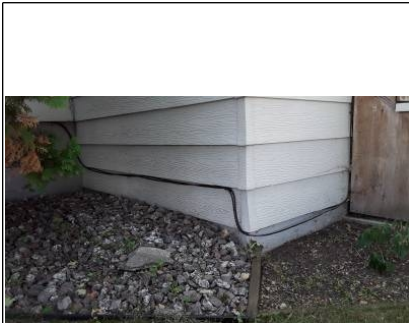
Comments Soil to close to siding to prevent damage to siding/framing recommend a clearance of 6-8" to grading be maintained

Soil to close to siding to prevent damage to siding/framing recommend a clearance of 6-8" to grading be maintained.

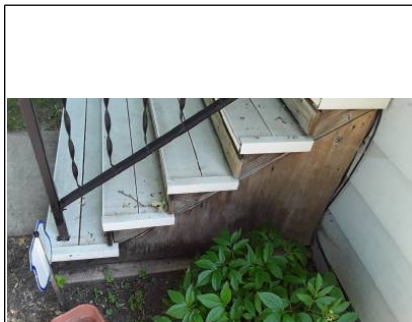
Comments Damaged wood on steps, recommend repair and/ replacement

Damaged/ rotted wood on steps,
recommend repair and/
replacement.

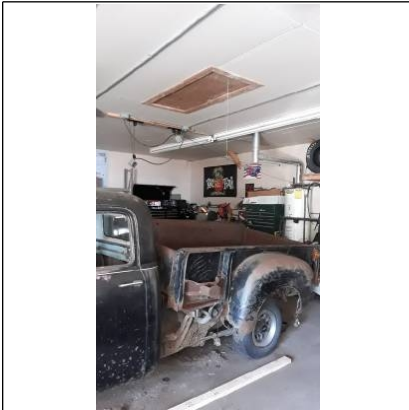
Access was blocked. Garage attic was not reviewed. Recommend evaluating once it can be accessed.

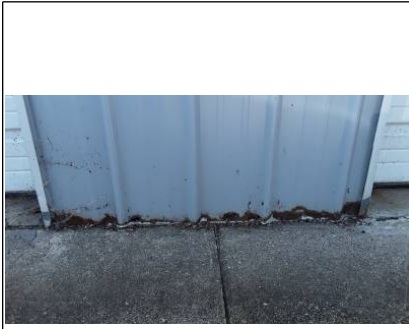
Comments Siding had some damage recommend repair

Siding had some damage
recommend repair.

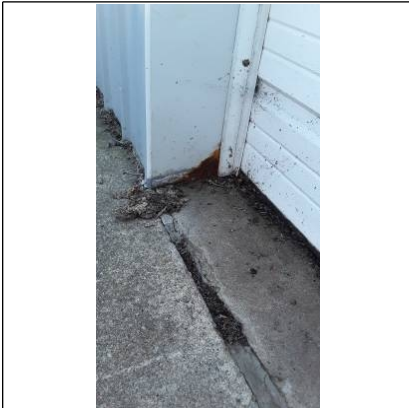
Comments Siding was in need of normal maintenance repairs.

Siding had some damage
recommend repair.

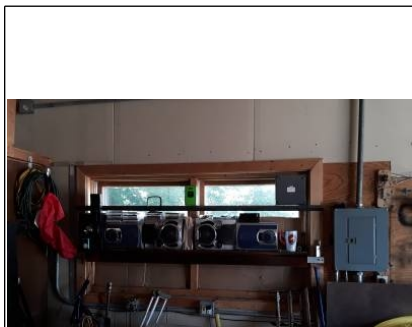
Not operated due to home owners belongings.

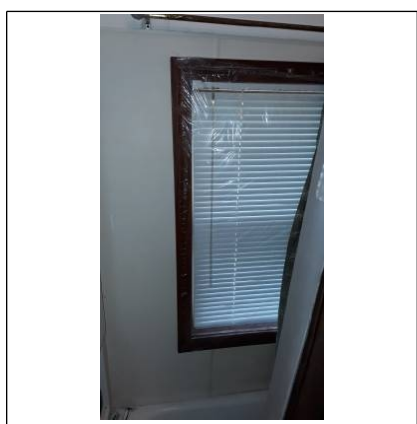
Comments Window(s) not operated due to winterizing plastic. Recommend monitoring for proper operation.
 Door would not close completely. Recommend repair as necessary.

Window(s) not operated due to winterizing plastic. Recommend monitoring for proper operation.

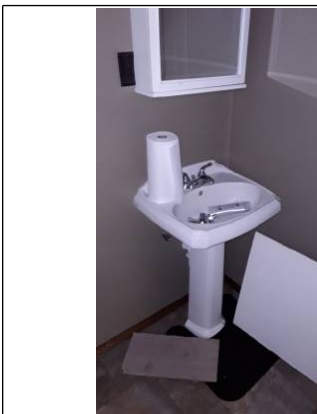
Bathroom under construction. Not evaluated.

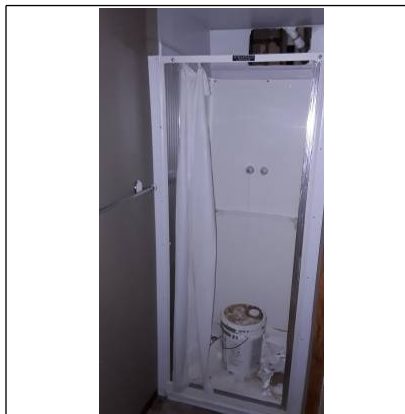
Bathroom under construction. Not evaluated.

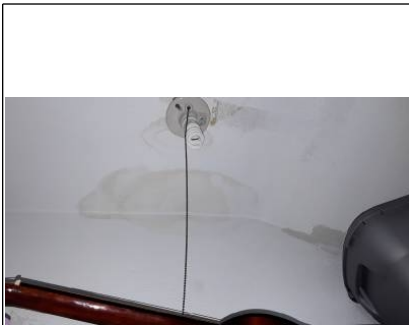
Signs of moisture leaks. Moisture meter showed it was dry at the time of the inspection. Recommend monitoring for potential future leaks.
